MARINE INVESTIGATION REPORT
M99C0008

CONTACTING BOTTOM WITHOUT GROUNDING

BULK CARRIER "JEAN PARISIEN"
NEAR JOHNSON POINT, ST. MARYS RIVER, ONTARIO
23 APRIL 1999

Report Number M99C0008

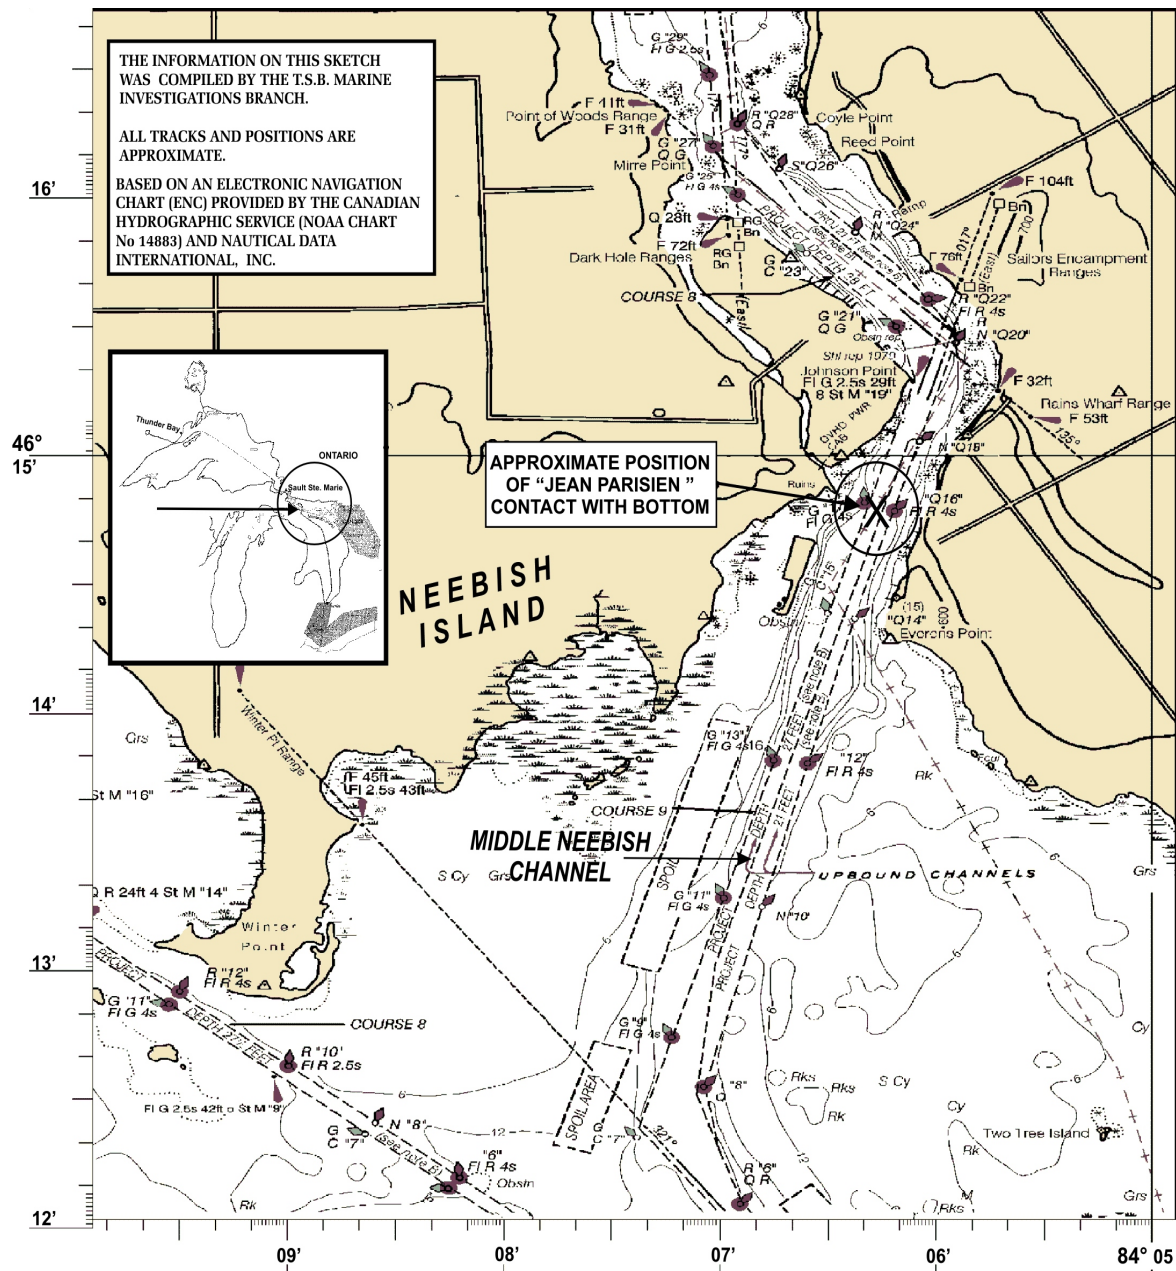
Appendix A – Chart of Area Showing Position of Grounding

Anticipating a port set after buoy Q16, the master favoured the centre of the Neebish Channel as he adjusted the course to steer between the two recommended navigable tracks provided by the sets of ranges and day beacons. The helmsman, as directed, adjusted the heading by steering 017°T. Upon completion of the new heading change, the vessel continued to set to starboard, not to port as anticipated. The ship's drift to starboard was confirmed visually by observing that right-hand day beacons continuing to close. At 1815, with more than half the ship's length past buoy Q16 and Q17 and the ship's speed at 6.7 knots, a noise was heard as the bottom shell plating contacted the river bottom. The vessel scraped the river bottom momentarily but maintained its course and heading as it passed buoy Q16. At that point the helmsman observed that the right-hand side day beacons were aligned, indicating that the vessel was in the eastern, shallower 6.4-m-deep section of the channel. The vessel contacted the river bottom at position latitude 46°14.75' N, longitude 084°06.3' W.¹ In this section of the channel, the river bottom is hard and forms a ledge with a minimal clearance below chart datum of 6.5 m (see Appendix A).

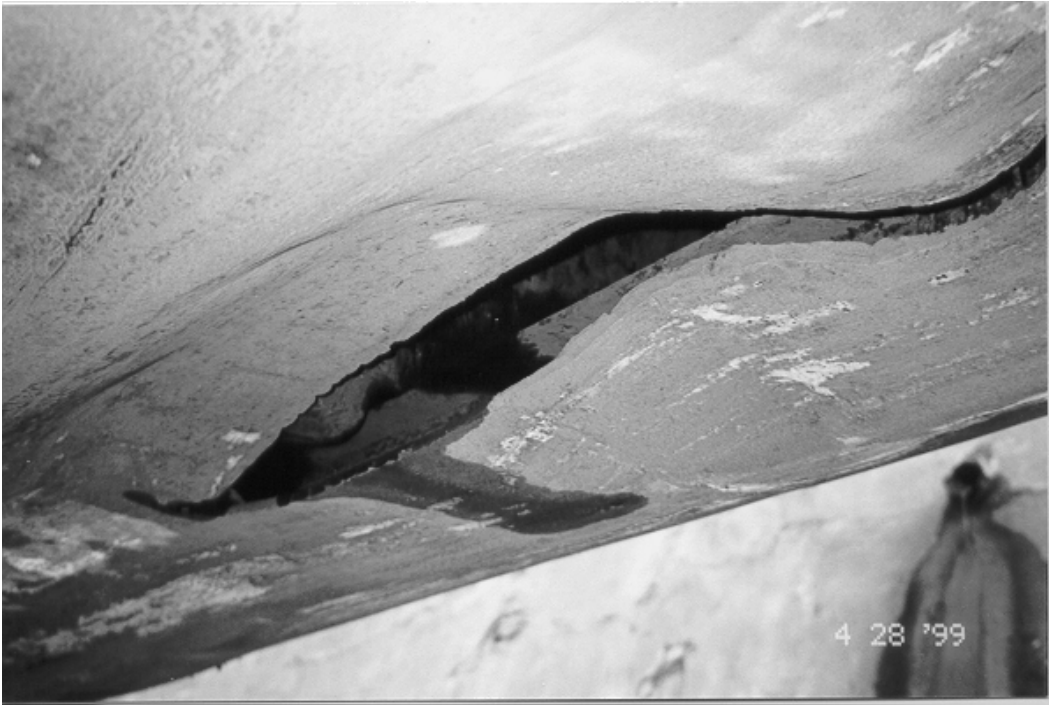
The impact had breached starboard water ballast tank No. 5 and the engine room void spaces. As a result, the ship soon developed a port list due to the loss of the starboard ballast water that had gravitated overboard until pressure equilibrium was reached at the waterline. There was no change in the soundings or ullage of any of the fuel tanks in the engine room; however, the cofferdams had been breached and flooded with water. There was no release of pollutants.

Starboard water ballast tank No. 5 and the cofferdam at its forward end were breached. The bottom shell plating of the tank was buckled and penetrated between frames 33 and 36 by a split approximately 1.5 m long and 20 cm wide. The bottom shell plating was damaged and set in approximately 12 to 16 cm, and extended inboard from the turn of bilge at frame 55 and aft to frame 24.

Normal navigation practices were followed on the "JEAN PARISIEN". With a pronounced trim by the stern of 3.3 m and a draught of 7.0 m aft, the "JEAN PARISIEN" was too deep to enter the east side, 6.4 m-deep lane of the Middle Neebish channel. As a result, the ship's bottom shell struck the river bank and the No. 5 starboard tank was set in some 20 cm.

Damage to starboard water ballast tank N°5.

Repairs requiring the replacement of approximately 14.4 tonnes of steel were completed to the classification society's approval and owner's standards.
